Manhole Inspection Summary

Manhole # S31II_008MH

Location Address: **124 LAFAYETTE AVE**

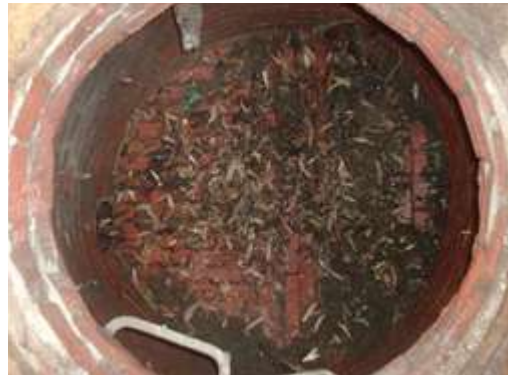
Top View

Channel debris.

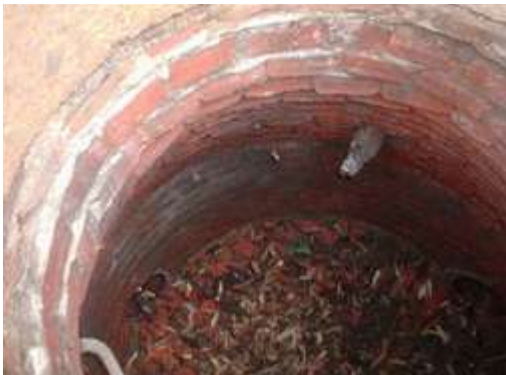
Defect

Adjustment deterioration and infiltration.
Corbel and Barrel infiltration.

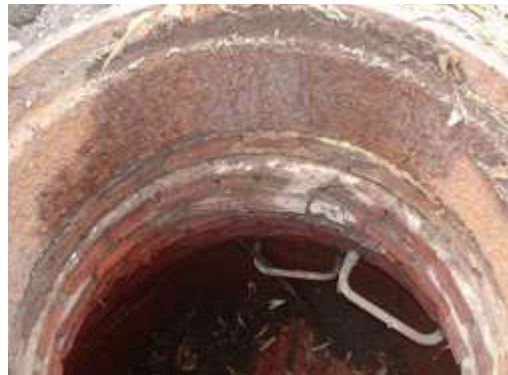
Defect

Adjustment deterioration and infiltration.
Corbel and Barrel infiltration.

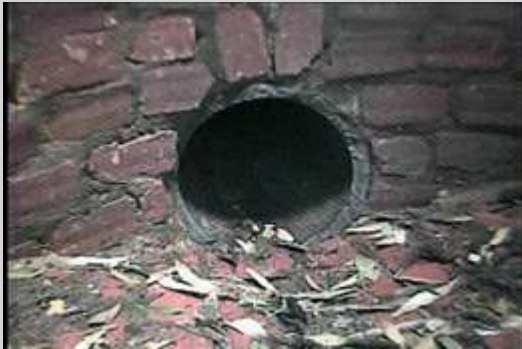
8 in. Circular Gravity Sewer Pipe Out @ 12 O'Clock

Infiltration: **Evidence** Pipe Seal Cond: **Cracked**

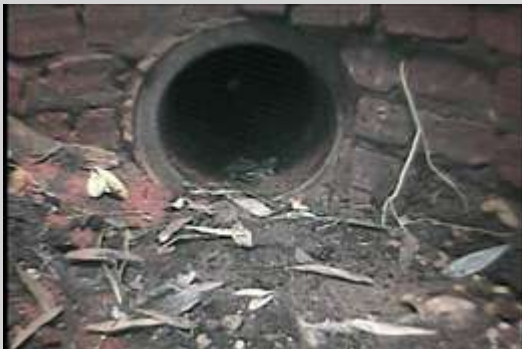
8 in. Circular Gravity Sewer Pipe Out @ 9 O'Clock

Barrel root intrusion.

Infiltration: **Evidence** Pipe Seal Cond: **Unknown**
